Screen failure Pebble Steel

Display problem repair the pebble samrtwatch steel. The screen was unreadable and solve this simple repair

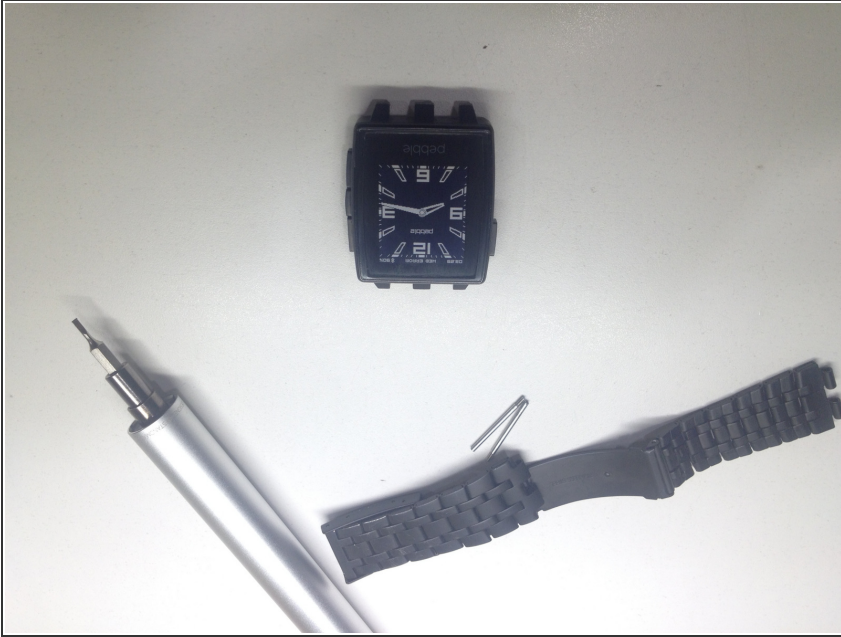
Step 1 — dismantle belts

- The first is to remove the belt. We will use a 1.5 mm flat screwdriver

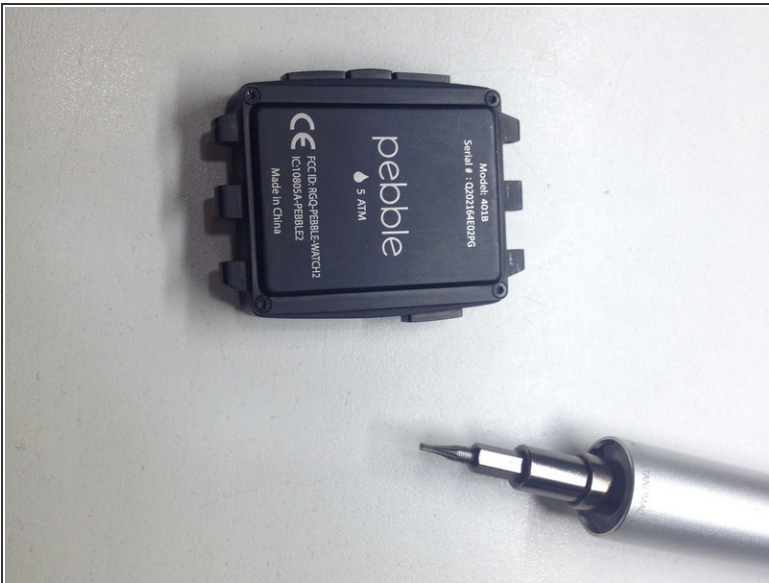
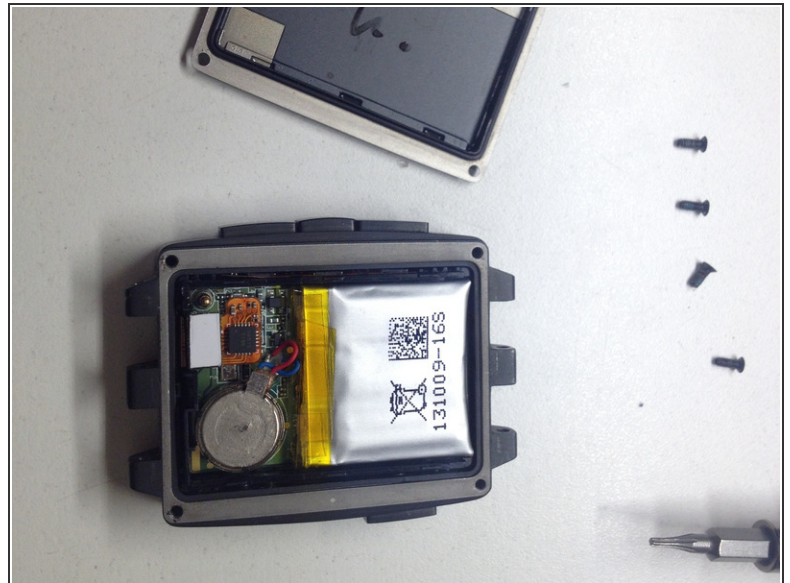
Step 2 — Dismantle rear cover

- Dismantle the cover of the watch using a screwdriver T-5, and taking care with the rubber gasket having, we will remove the metal cover.

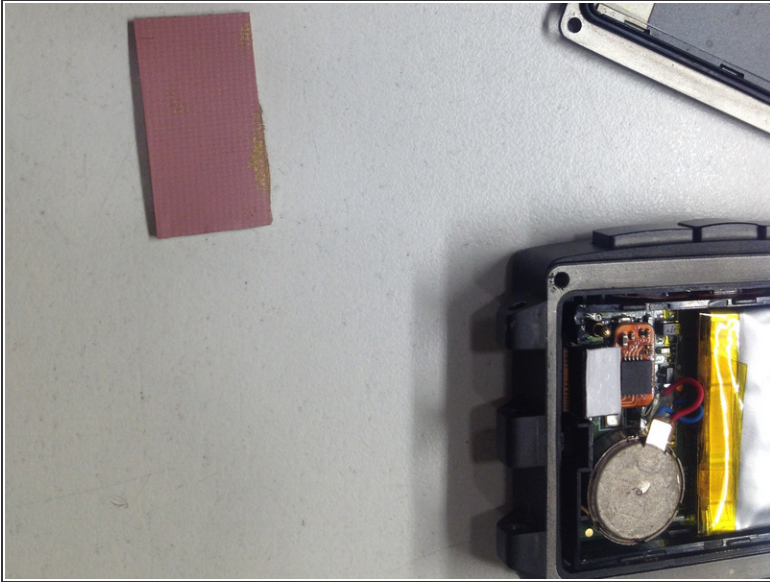
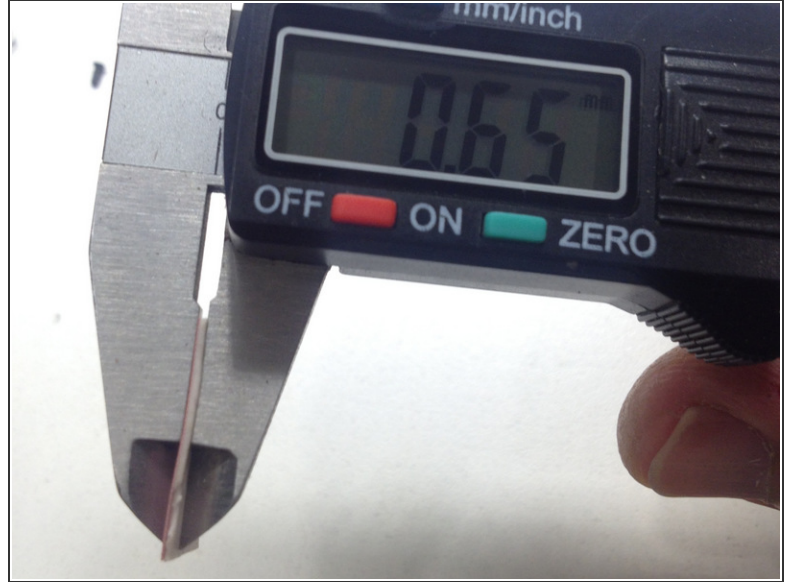
Step 3 — Search and cut a soft rubber

- This step will look for a dissipative of carrying notebooks for microprocessor silicone. Not having it could use a piece of soft rubber, not exceeding 0.65mm thick

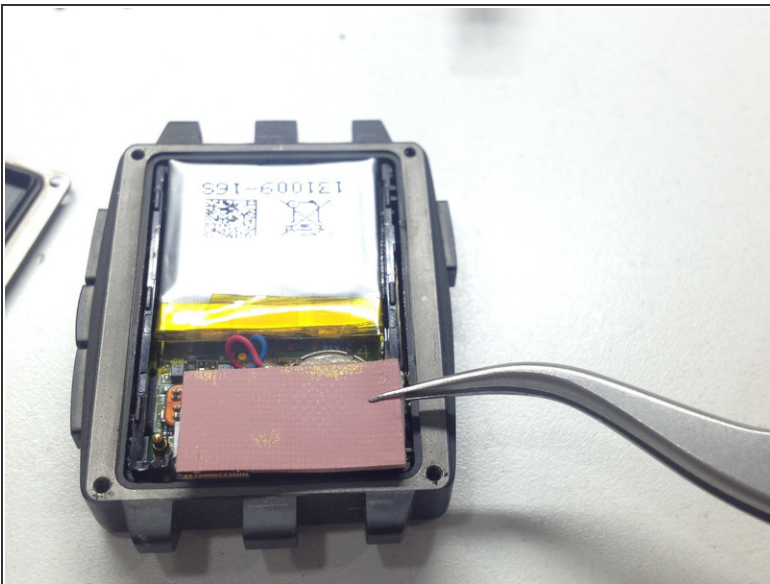
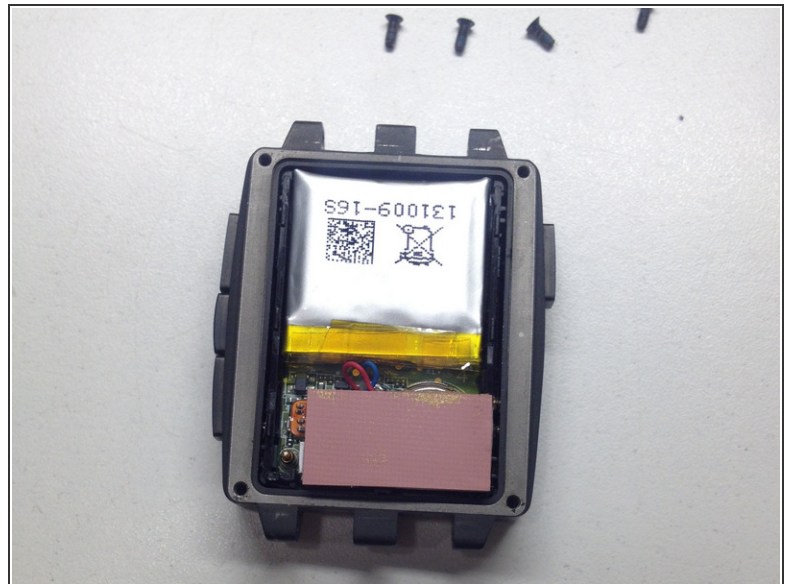
Step 4 — place rubber

- We will put this paste on the bottom right of the watch, on the vibrator and connector corner of the screen. You have to clear the gold-plated connector on the left as it makes contact with the lid.

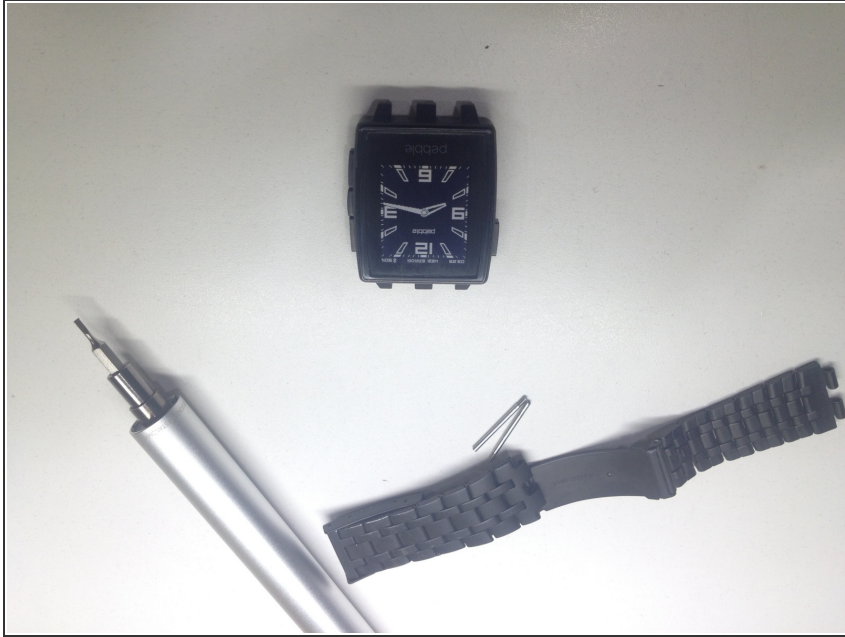
Step 5 — Close and READY !!!!

- Finally we set the clock by reversing the steps. *'++ Is important to place the lid put first the two screws above and then the bottom two.'* (This forces all internal chassis, thus exerting pressure on the rubber contact of the screen.)
